**Former Crawford Power Generation Station
3501 S. Pulaski Road
Turbine Building: Building Status**

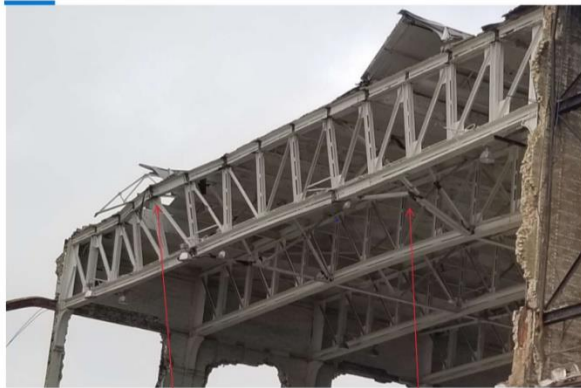
CRAWFORD POWER PLANT, EAST ELEVATION OF TURBINE BUILDING-ROOF TRUSS
5/4/20 BL01036

TRUSS DAMAGED, DEFLECTING OUTWARD,
LATERAL SUPPORT CONNECTED TO ADJOINING
TRUSS BENT.

THE ABILITY FOR THE ROOF TO SHED WATER
PROPERLY HAS BEEN COMPROMISED.

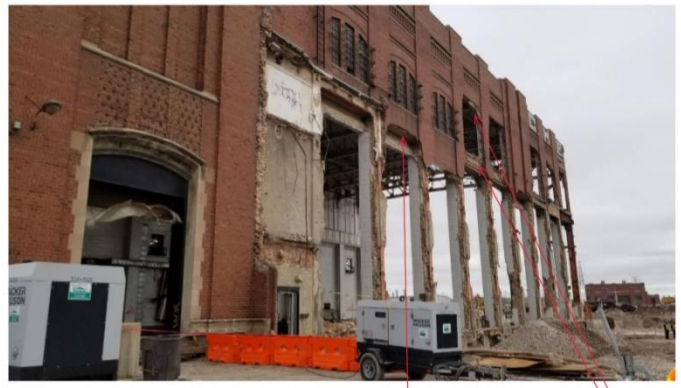
CRAWFORD POWER PLANT, SOUTH ELEVATION OF TURBINE BUILDING
5/4/20 BL01036

NEARLY 50% OF THE TURBINE BUILDING HAS BEEN DEMOLISHED AT THE EAST END OF THE BUILDING.
THE MASONRY HAS BEEN REMOVED EXPOSING THE STEEL CONNECTIONS AS WELL AS LEAVING
BRICK UNSUPPORTED AT NEAR A 3 STORY HEIGHT.
